# Evaluation of Candidate Stirling Engine Heater Tube Alloys for 1000 Hours at 760° C

John A. Misencik National Aeronautics and Space Administration Lewis Research Center Cleveland, Ohio 44135

November 1980

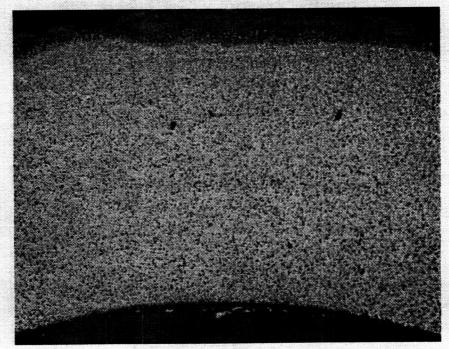
(d-2) 901 Hours; hydrogen filled. (d) 19-90L.

Tubing failures occurred in four of the six alloys that contained helium. One tube of A-286 failed at 710 hours, one tube of Incoloy 800 failed at 614 hours, and six tubes of 19-9DL failed at 164 to 273 hours. Six tubes of Nitronic 40 failed during the endurance test at times ranging from 120 to 192 hours. No tubing failures occurred in the N-155 or 316 stainless-steel alloys.

In those modules that contained hydrogen, only two experienced failures. These were 19-9DL at 820 to 973 hours and Nitronic 40 at 163 to 619 hours. These two alloys also had the most failures in those tubes that contained helium.

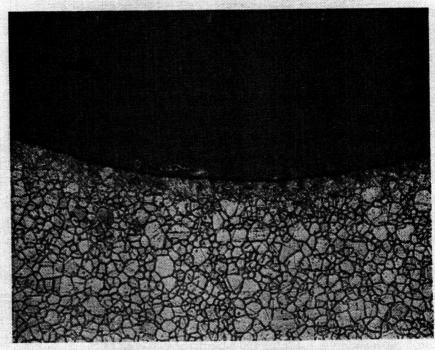
Figure 11. -Typical cross section of inner surface of hydrogen-filled tube after Stirling simulator rig exposure. Material, 316 stainless steel; magnification, 500.

To determine if any oxide layers were present on the inside surface of the tubes, cross sections of the exposed tubes were examined metallographically and by X-ray diffraction. Figure 10 shows the cross sections for each alloy at a magnification of 100X. Figure 11 shows a typical inside surface of a tube at 500X. No oxide layer could be identified on any of the inside surfaces at a magnification of 500X. However, X-ray diffraction studies made on particles scraped from the inside surfaces of the tubes identified trace amounts of sesquioxides (Fe<sub>2</sub>O<sub>3</sub>-Cr<sub>2</sub>O<sub>3</sub>). This identification was made with difficulty since the amount of oxide on the inside of the tubes was very small.

- 3. The reduced permeabilities during the later segments of the endurance tests are thought to be associated with formation of thin oxide films on the inside surfaces of the tubes. It is further postulated that these films require the presence of strong oxide formers such as chromium, manganese, titanium, silicon, or aluminum in the alloy plus oxygen as an impurity in the hydrogen.

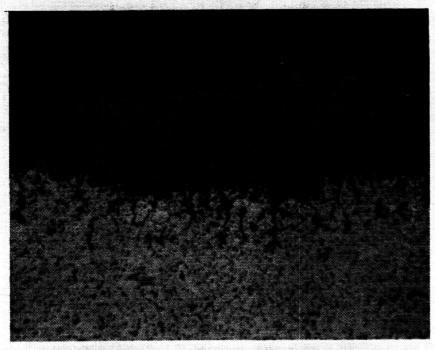
Figure 12. -Inner surface of hydrogen-filled Nitronic 40 tube after 619 hours in Stirling simulator rig.

The inner edge of the Nitronic 40 tube that was exposed to hydrogen is shown in figure 12. A reaction has taken place on the inner edge to a depth of approximately 0.06 mm. The Nitronic 40 tube that was exposed to helium for 542 hours did not show this effect. The nature of this reaction has not yet been identified.
